# **Final Report**

## **TECHNICAL COMMITTEE FOR INSPECTION OF THREE BREACHED TANKS IN BBMP LIMITS AND FOR SUGGESTIONS TO PREVENT FURTHER SUCH INCIDENTS.**

Ref: G.O. No.: UDD 250 MNY 2018 (Part-1), Bengaluru dated 2<sup>nd</sup> December 2019.

**On 20<sup>th</sup> January 2020**

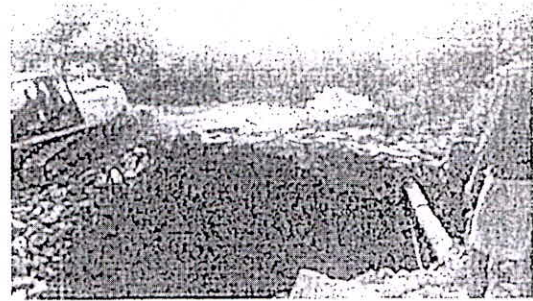
- iv) The breach in the Hosakerehalli tank bund is attributable to inadequate compaction of embankment near the sluice after the insertion of pipes and improper closing of pipe inserted in the bund near the sluice aggravated by heavy rains and the blockage in the raja kaluve downstream of the surplus weir.**

Photo-3(b) & 3(c) – Hosakerehalli tank- View of breach section

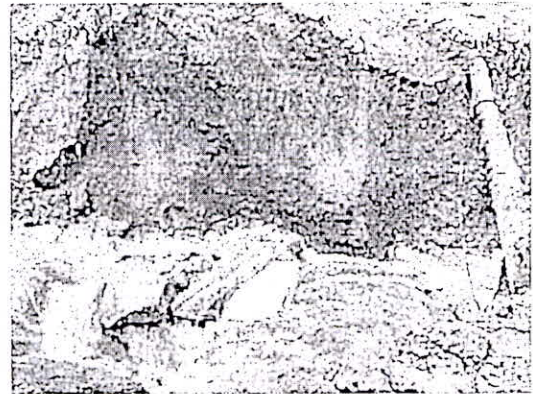
Photo-3(d) & 3(e) – Hosakerehalli tank- Reconstruction of breach section

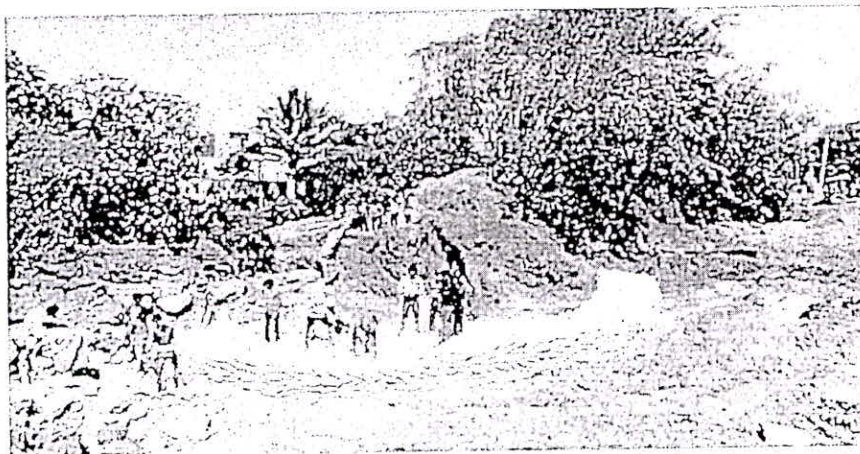
Photo-4(c) – Hulimavu tank bund restoration work after the breach

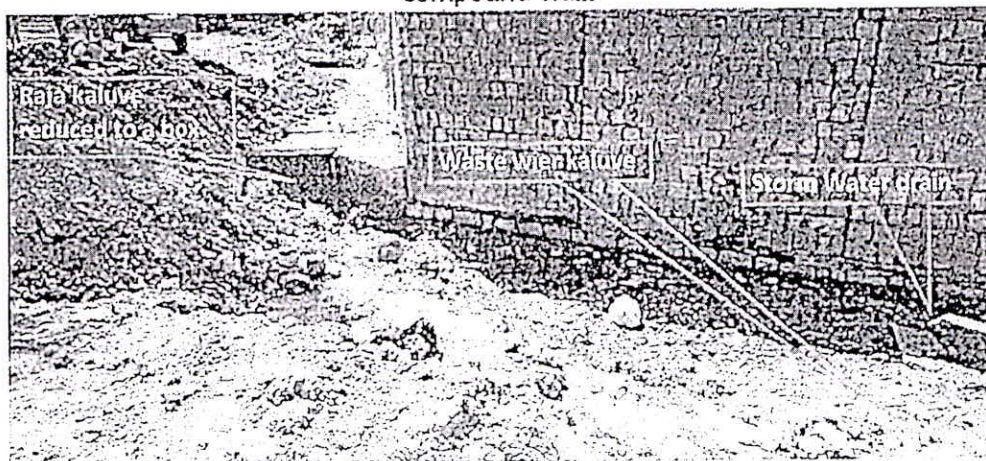
Photo 7(a) above & 7(b) below – Waste weir of Kelaginakere Bairasandra tank is completely encroached with debris. UGD lines are carried in the tank bund. Tank bund is encroached by filling the debris. Storm water drain is being constructed by the side of compound wall.

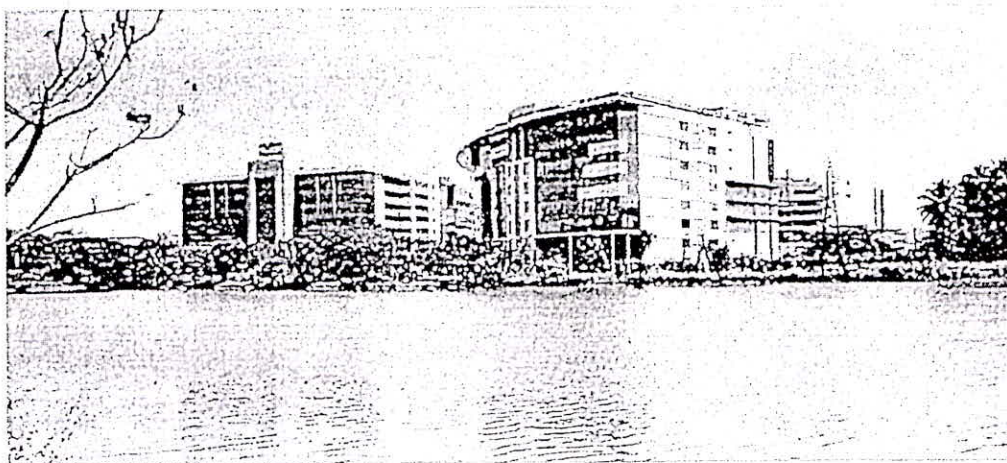
Photo 7(e) – Encroachment of Kelaginakere Bairasandra tank bund

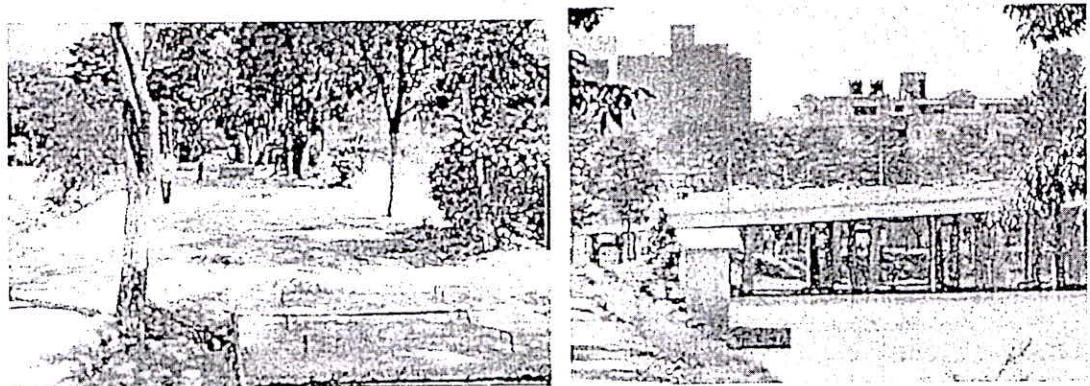
Photo 8(c) & 8(d) – Storm water line and chambers seen in the bund. Right side Flyover constructed in inside the tank. It was informed that it is proposed by BMRCL to reduce the bund width by constructing diaphragm wall in the bund and cutting off the outer part of bund to expand the road way below the tank in order to carry the Metro line in between the roadway.
